15-- INTERSTATE COMMERCE COMMISSION.

**REPORT OF THE CHIEF INSPECTOR OF SAFETY APPLIANCES
COVERING HIS INVESTIGATION OF AN ACCIDENT WHICH OC-
CURRED ON THE ST. LOUIS & SAN FRANCISCO RAILROAD NEAR
CHELSEA, OKLA., ON OCTOBER 29, 1913.**

DECEMBER 29, 1913.

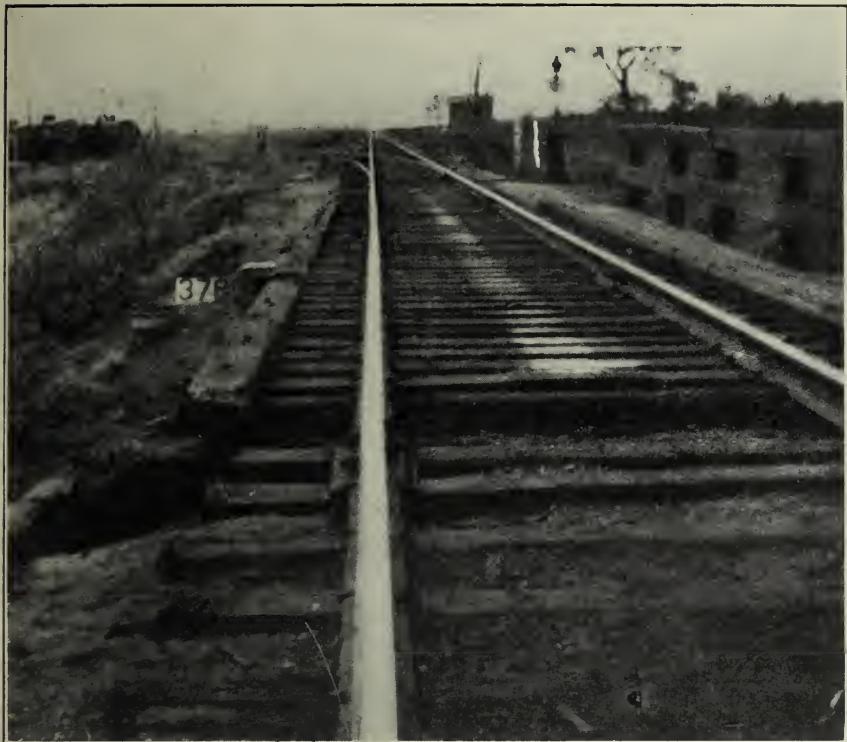
At a point 1,800 feet east of the point of derailment was found a rail joint at the approach of a bridge where three spikes were so loose as to enable them to be removed by hand. This condition is shown by illustration No. 1.

No. 1.—Approach of a bridge at which three spikes were removed by hand from a rail joint.

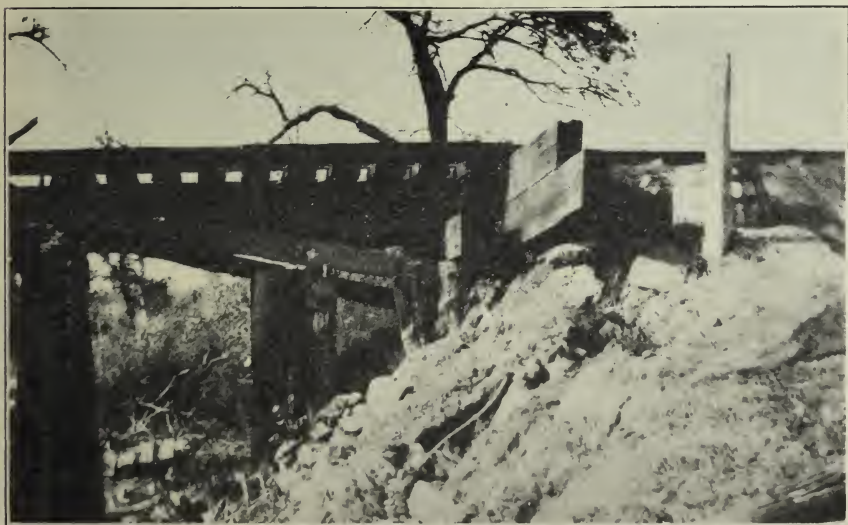
At bridge No. 378.1, located approximately 1,100 feet east of the point of derailment, the approaches were found to be in extremely bad condition. Illustration No. 2 shows the condition existing at the eastern approach of this bridge, while illustration No. 3 shows the condition of the ballast at this point, three of the ties having no ballast for a distance of from 2 to 3 feet on the right-hand side. During the course of this examination a train passed over this bridge, and it was found that the track at this approach was depressed 3 inches

No. 2.—Conditions existing at eastern approach of bridge No. 378.1.

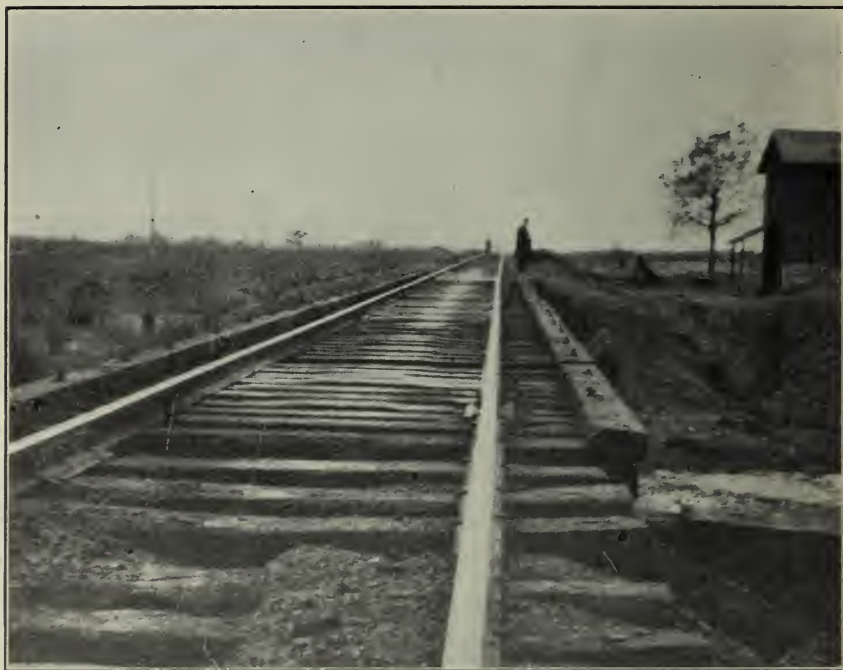
No. 3.—Condition of ballast at eastern approach of bridge No. 378.1.

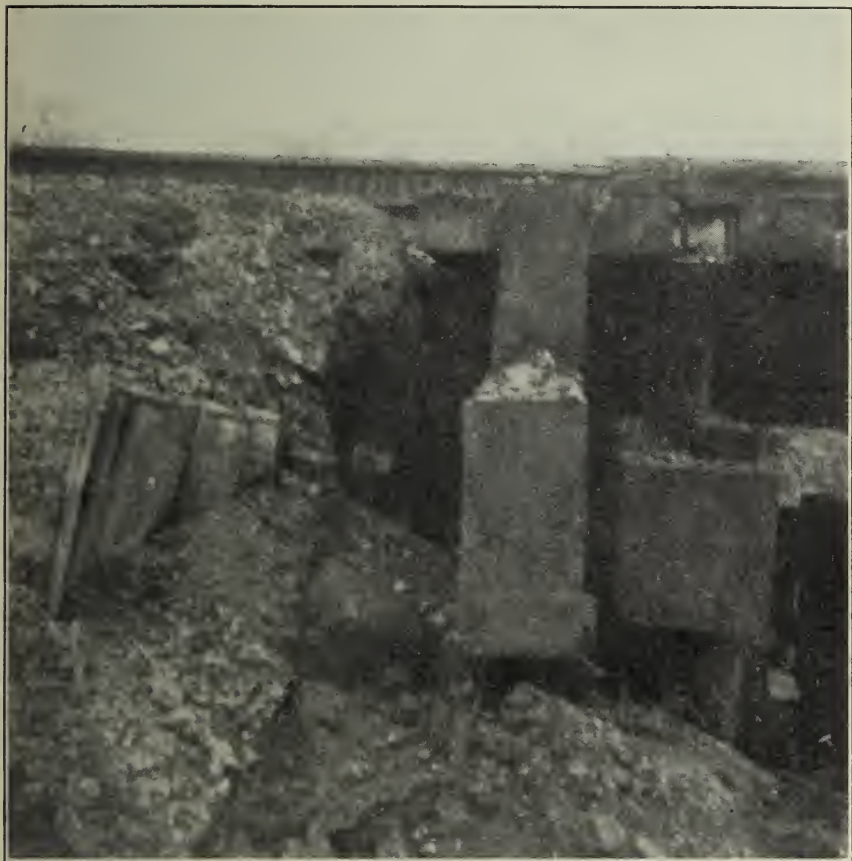
under the weight of the train. Illustration No. 4 shows the approach at the western end of this bridge. Notwithstanding the conditions existing at this point, however, there was no slow order governing the operation of trains over this bridge; in fact, the only speed limit of any kind affecting any of the track in this vicinity was the special time-card rule which provided that no passenger train should exceed a speed of 50 miles per hour over this part of the road.

No. 4.—Conditions existing at western approach of bridge No. 378.1.

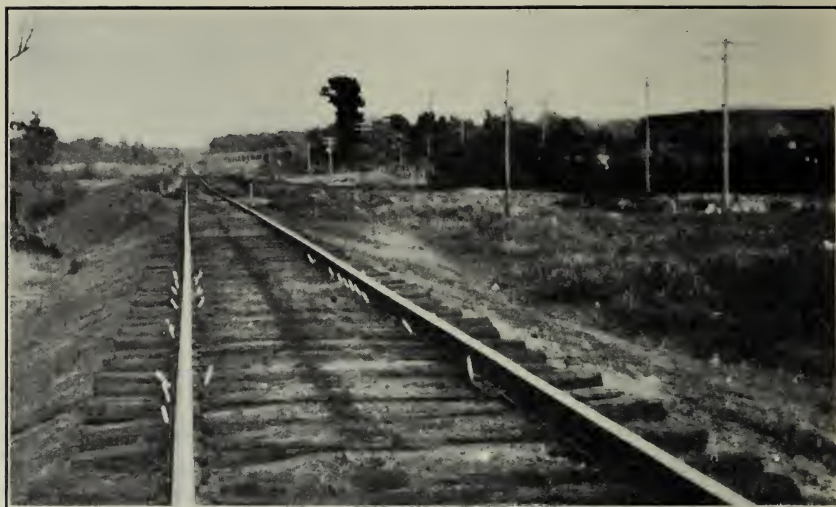
At a point 900 feet east of the point of derailment a rail section was found under which 10 out of the 20 ties were decayed. A total of 30 spikes were removed by hand from the ties under this rail section.

The condition existing at this point is shown in illustration No. 5, which shows the spikes which were removed by hand.

No. 5.—Rail section under which 10 ties were decayed; 30 spikes removed by hand.

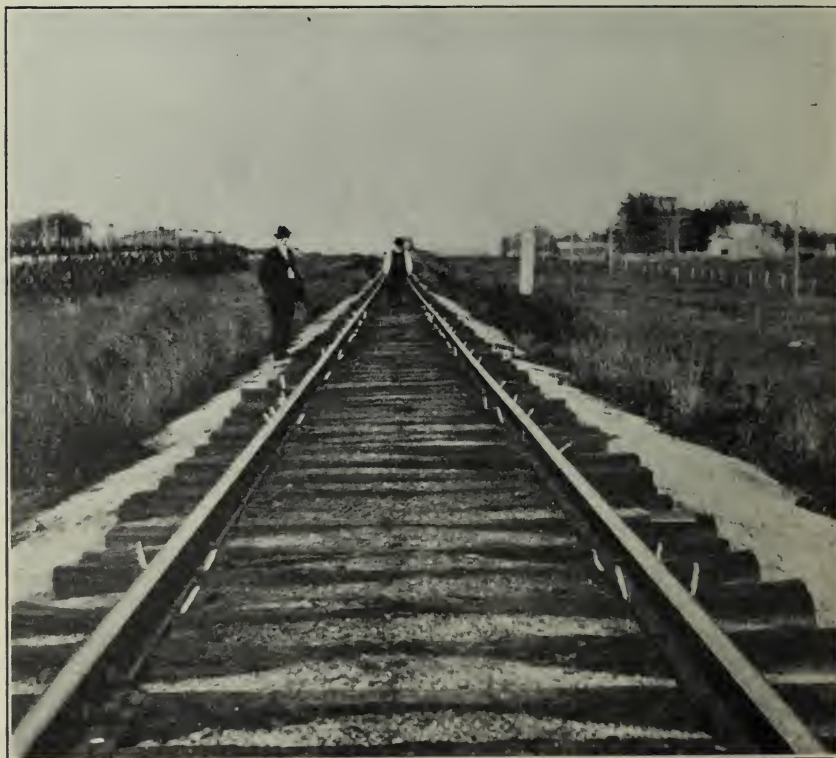
in use. Of the 16 defective ties under this rail 15 were successive ties. In this same distance of seven rail lengths there were 142 loose or missing spikes and 126 spikes which could be removed by hand, a total of 268 spikes out of 536 in use which had practically no holding power. Under the fifth, sixth, and seventh rail lengths east of the bridge there were 96 spikes which could be removed by hand. Illustration No. 6 shows the spikes in this three-rail section which

were removed by hand. There were also 54 loose or missing spikes in this same three-rail section. In other words, out of 228 spikes in this three-rail section only 78 were serving any practical purpose. Illustration No. 7 shows a rail joint from which all four spikes were removed by hand, the spikes taken from the rail joint being seen resting on the top of the rail. The spikes seen resting against the web of the rail were also removed by hand. Out of 14 rail joints in this seven-rail section only three had all the spikes in good condition.

No. 6.—Section of three rail lengths from which 96 spikes were removed by hand.

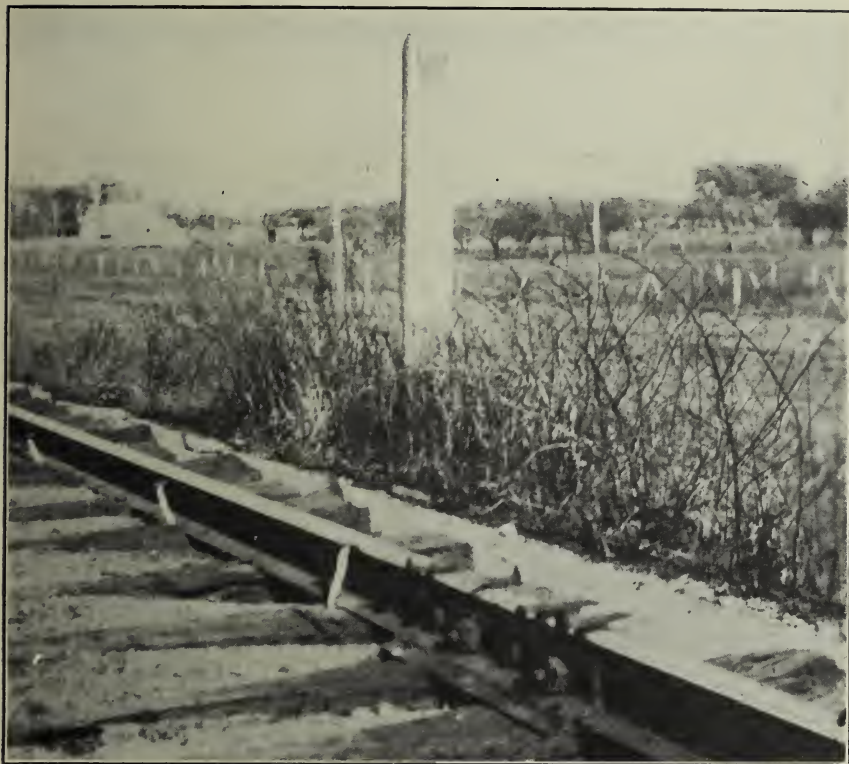
No. 7.—All the spikes in this rail joint removed by hand.

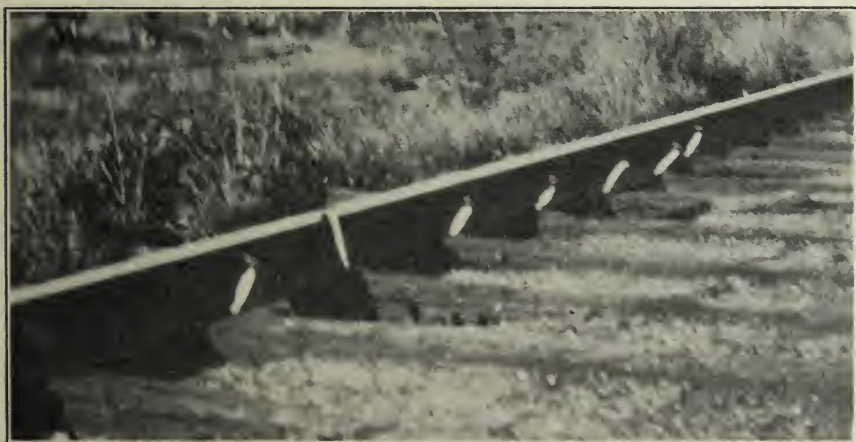
No. 8.—Spikes removed by hand from seven successive ties.

At one point on the inside of the sixth rail from the bridge the spikes were removed by hand from seven successive ties, as shown by illustration No. 8, while at another point embracing parts of rail sections Nos. 6 and 7 the spikes were removed by hand on the outside of the rail from nine successive ties, eight of them being at the end of one rail, while on the inside of the rail at this point the spikes could be removed from six ties, and the spikes were loose on three others.
